# The Application of High-Pressure Connectors in UHPLC

White Paper

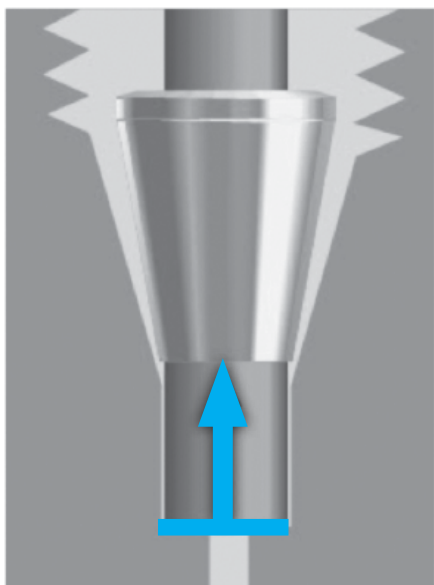
Figure 1. Tubing slippage

Because system pressures in UHPLC can exceed 15,000 psi (1,034 bar), the physical demands on the tubing connections can be very significant. Due to the higher pressures of UHPLC coupled with the pressure cycling that can occur in certain areas of the system (e.g., at the injection valve), one of the biggest problems UHPLC users can face is tubing slippage.

In the areas of the system where the highest amount of pressure is experienced, the conically-shaped fittings work to hold the tubing against the bottom of the receiving ports in each connection. However, at the same time, the fluid in the system's flow path fights against the holding power of the fittings and works to drive the tubing away from the bottom of the receiving port. Of course, any movement of the tubing away from the bottom of the receiving port can result in dead volume, which can lead to the chromatographic problems highlighted above.

Unfortunately, this can be very difficult to detect because the movement of the tubing often occurs slowly. It's possible for there to be no sign of problems with the flow path connections (e.g., no evidence of leaking, no loss of pressure, etc), while the chromatographic results continue to deteriorate due to the increasingly larger dead volume chamber being formed in the receiving port.

In a standard 10-32 coned receiving port designed for 1/16" OD tubing, for every .001" the tubing slips past the tip of the ferrule, more than 50 nanoliters of dead volume is created.

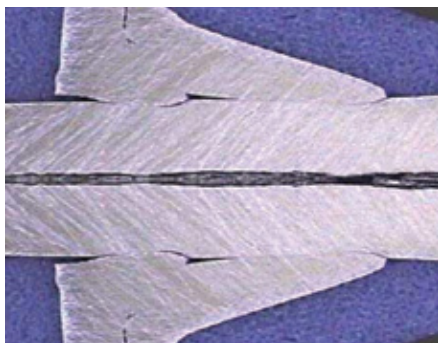
**Figure 2.** Tubing ID compression

However, some of the most popular all-metal fittings require a high-torque load to ensure they swage properly on the tubing wall. When the need for a high-tightening torque is coupled with the axiom that says “you can never tighten too much,” the stage is set to significantly compress the ID of the flow path tubing.

### **Compression shown in Figure 2 results in several problems:**

- › Higher system back pressures.
- › A “throttling effect” on the fluid, resulting in increased turbulence and excessive mixing between the sample and mobile phase.
- › Increased probability of tubing clogs due to suspended particulate matter.

Similar to the problem with tubing slippage, tubing ID compression is also difficult to detect. There are no leaks present and no loss of pressure, making this problem tough to troubleshoot and often resulting in unnecessary system down time and repair expenditures.

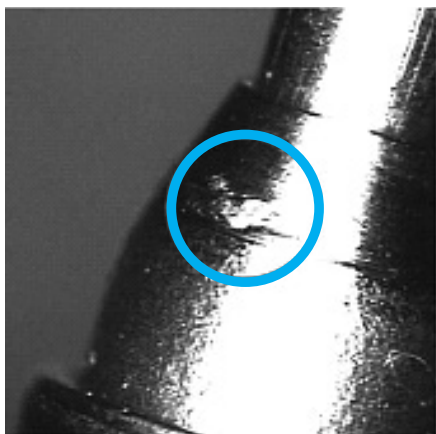
Figure 3. Galling damage

The high torque required to successfully swage an all-metal fitting system on the flow path tubing doesn't just result in tubing ID compression. Depending upon the amount of tightening torque applied, it's possible for material to be ripped from the receiving port and transferred to the surface of the ferrule.

When galling occurs, the receiving port is damaged — possibly beyond use. In severe cases, the material that is ripped from the receiving port serves as a type of “glue” that forces the ferrule to stick in the receiving port. This makes it difficult to remove the fitting from the port and often results in a very expensive repair.

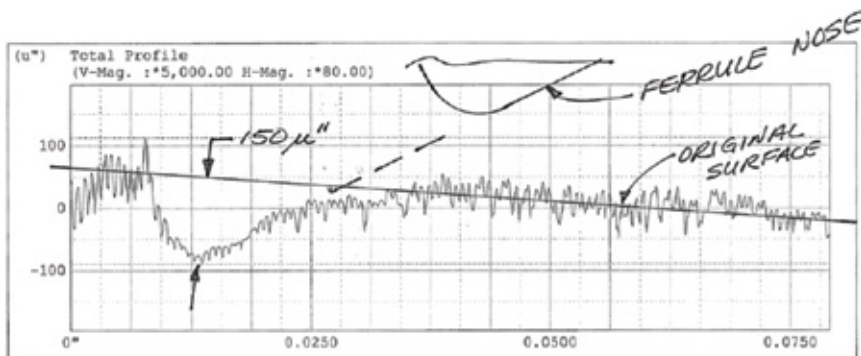
Even if galling doesn't occur, it's very typical for all-metal fittings to slightly damage the conical surface inside the receiving port. As seen in Fig. 4, it's possible for a ferrule to indent the conical surface by as much as 150  $\mu$ -inches.

Figure 4. Profilometer scan showing that galling has occurred

The strength of a connection relies partially on the quality of the receiving port. While competitive products can leave a damaging impression on the receiving port, as great as 150 μ-inches (shown in Figure 4 on page 3), the VHP-200 fittings create less than half of the impression on the receiving port (see Figure 8).

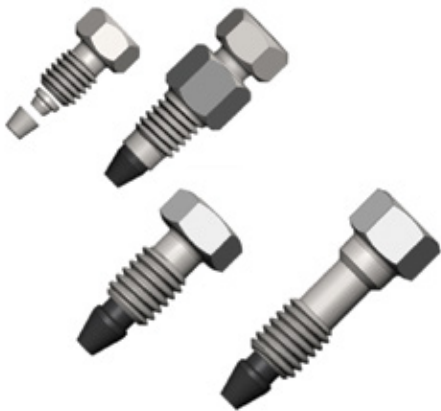
**Figure 5.** VHP-200, VHP-300, VHP-320, and VHP-325 UHPLC Fittings

- › The VHP-200 series is the highest rated at 30,000 psi (2,000 bar) and serves as a "drop-in" replacement for stainless steel two-piece ferrule systems.
- › The VHP-300 and VHP-320 series offer the added benefit of reusability, allowing the same fitting to be used to connect tubing in different receiving ports over and over again without needing to replace the fitting each time.

Through the use of a front ferrule manufactured from a proprietary PEEK-polymer blend, the VHP-300 and VHP-320 fittings ensure a biocompatible and inert fluidic seal without the risk of galling or damage occurring to the conical surface inside the receiving ports. Additionally, the internal ferrule—featuring patent-pending technology—helps hold the tubing in place securely without swaging onto the tubing. This feature allows these fittings to either connect the same tubing into multiple ports (e.g., when columns are changed on a system) or connect different tubes into the same port (e.g., when reducing the flow path tubing ID to account for lowering the system flow rate).

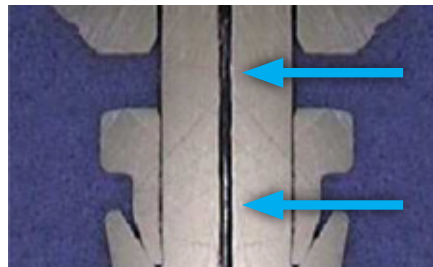
The VHP-200 fitting requires the most amount of tightening torque, yet it does not restrict the inner diameter of the tubing, as seen in the photo.

Additionally, even though the VHP-300 and VHP-320 fittings employ the use of a stainless steel “back ferrule”, the slotted design of this ferrule leaves a uniform fluid passage through the inner diameter of the tubing, even after multiple tightening cycles.

Figure 7. Ultra high pressure fitting with internal compression ferrule

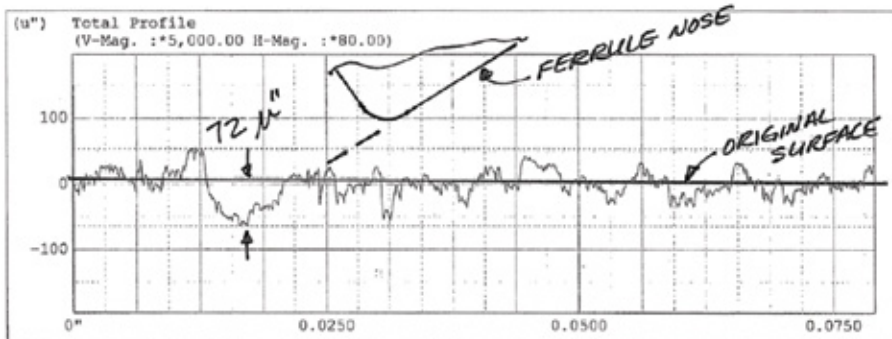
Additionally, because the VHP-300 and VHP-320 fittings use a polymer ferrule for the forward sealing function, these fittings will not create any measurable impression on a stainless steel receiving port surface. This helps to increase the number of cycles a quality connection can be made into a receiving port.

Figure 8. Profilometer scan showing that galling has occurred
